2023 Sediment Pre-Design Investigation Report

Orrington Reach Capping Remedy

March 2024

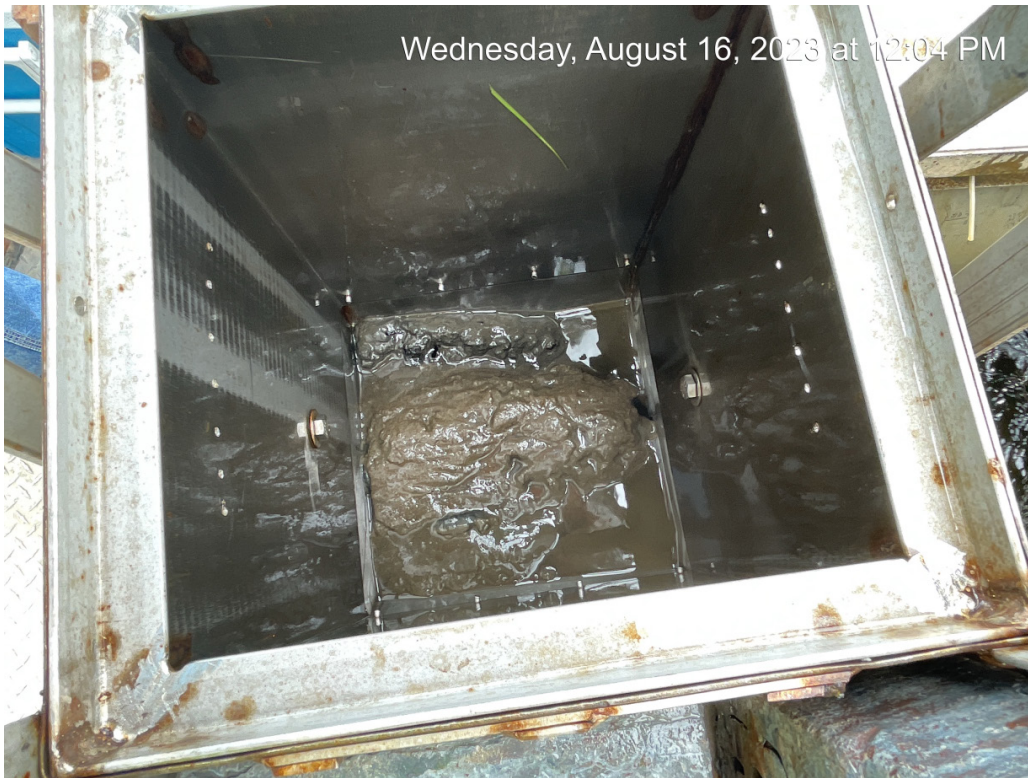
Photograph 4. East Cove 3 OR-PDI-07 (August 16, 2023)

- The sample depth interval was less than 0.5 ft bss at three locations due to difficulty triggering the sampling device to close: East Cove 3 location OR-PDI-07, Bartlett Cove location OR-PDI-27, and Area F location OR-PDI-59 (Table 2).
- The samples from locations OR-PDI-07 and OR-PDI-27 were collected by box core after multiple attempts using the Ponar dredge did not recover sufficient sample volume as the Ponar dredge did not close fully.
- At East Cove 3 location OR-PDI-07 (Figure 2) and East Cove 7 OR-PDI-40 (Figure 4), analytical chemistry samples were collected using the box core because the Ponar dredge did not recover sediment despite multiple attempts. The soft sediment present at these locations did not trigger the pin-release mechanism of the Ponar to close.

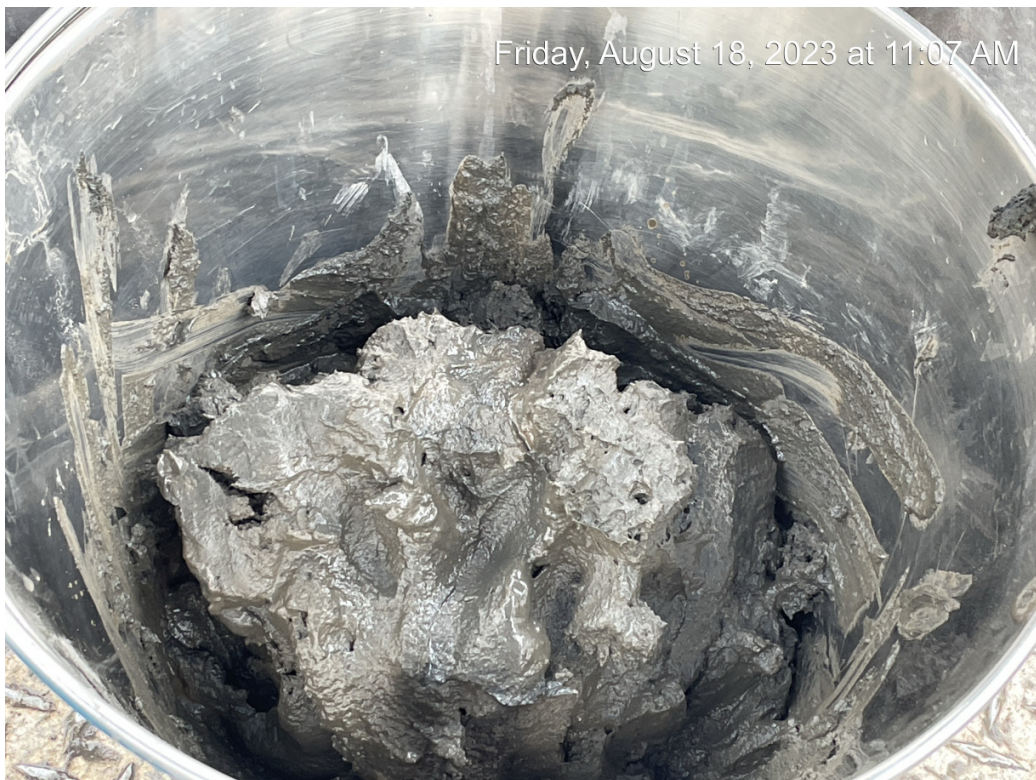
- OR-PDI-33 was sampled to 1.5 ft bss with the slam bar. No difference in sample material, which was identified as silt, was observed across the 0- to 1.5-ft bss interval as compared to the 0- to 0.5-ft bss sample that was collected via Ponar dredge, and the material collected by the slam bar was not submitted for analysis.

Photograph 19. East Cove 7 OR-PDI-33 (August 18, 2023)

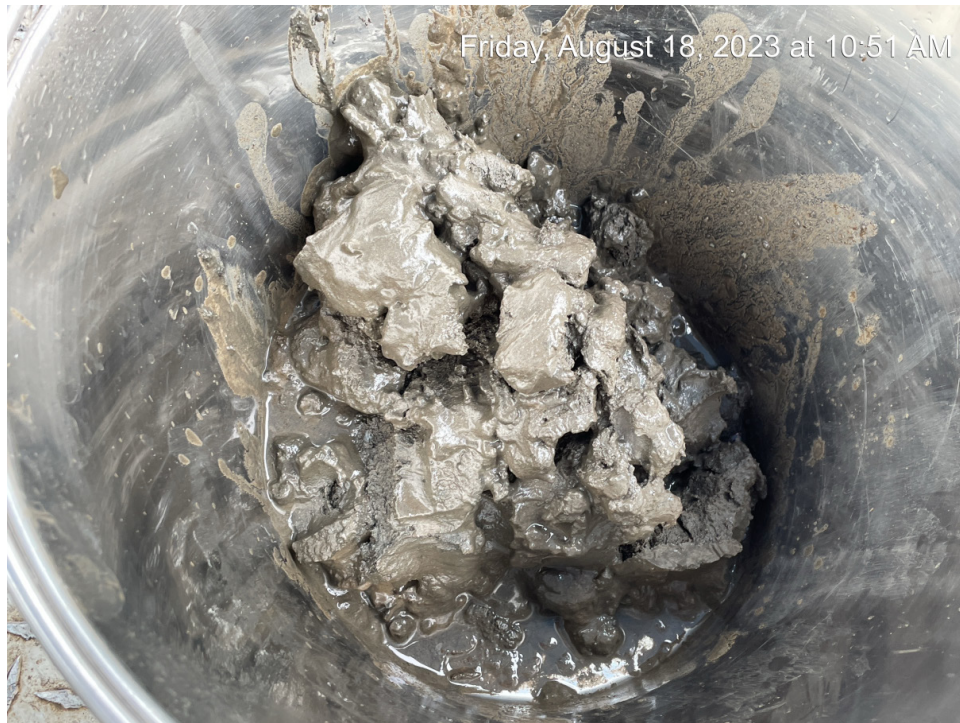
- OR-PDI-34 was sampled to 1.8 ft bss with the slam bar. Silt was observed from 0 to 1.5 ft bss. Very fine brown woody fibers were observed in a less than 0.25-in.-thick layer at 1.3 ft bss. A separate lithologic layer described as silty clay was identified from 1.5 to 1.8 ft bss. Because separate lithology layers were observed, two separate geotechnical samples, one from 0 to 1.5 ft bss and one from 1.5 to 1.8 ft bss, were collected from this location and submitted for analysis.

- Two geotechnical samples were collected from East Cove 7 location OR-PDI-34, based on field observations of a variance in lithology in the 0- to 1.5-ft bss and 1.5- to 1.8-ft bss intervals. Very fine brown woody fibers were observed intermixed with silt in a very thin layer of less than 0.25 in. thick at 1.3 ft bss. The 0- to 1.5-ft sample exhibited a higher moisture content and a lower density; both samples were classified by GeoTesting Express as elastic silt.

Photograph 20. East Cove 7 OR-PDI-34 (August 18, 2023)

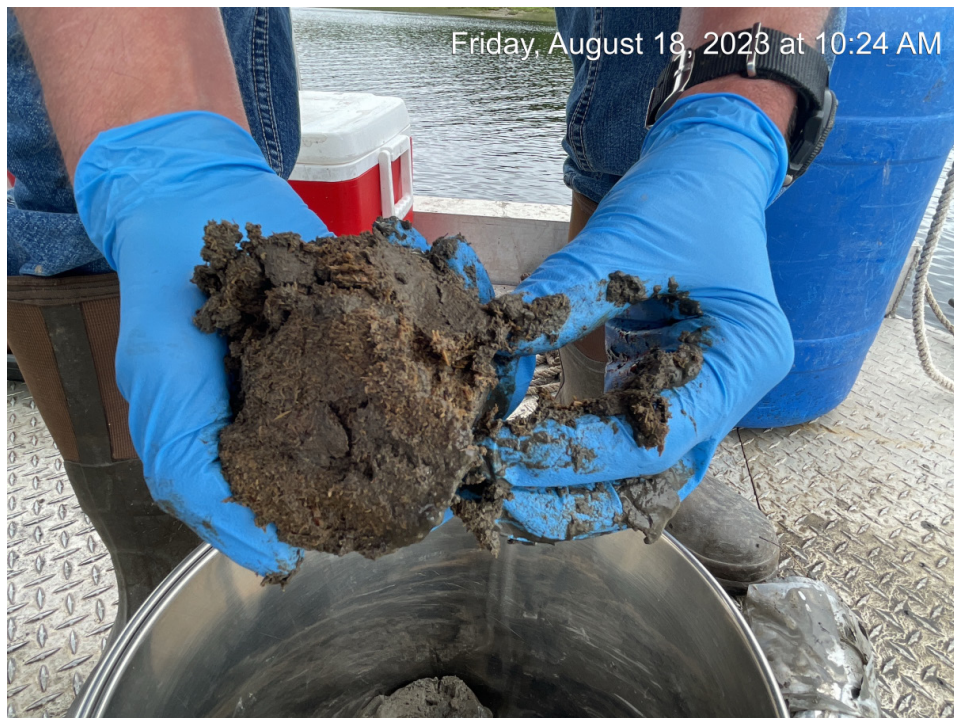
Sediment from all locations was reviewed for the presence of woody debris during the August 2023 sampling event. Wood waste was observed in only one location, OR-PDI-34 in East Cove 7. The wood waste at OR-PDI-34 was noted to consist of very fine woody fibers within the sediment matrix. These materials were not present as a discrete layer of greater than 0.5 in., and a separate wood waste sample was not collected.

Remarks Recovered 1.8' with slam bar. Thin layer of brown organics, decayed woody fibers at 1.3'. Ponar grab 0.5' of same SILT.

Photograph 21. East Cove 7 OR-PDI-34 Woody Fibers (August 18, 2023)

Woody debris was observed in only one location and was not present at that location in sufficient quantity to sample. These data suggest that the role of woody debris accumulation as a source of mercury redistribution to intertidal flat sediment is not likely to be significant and is unlikely to be a source of recontamination to the TLC following placement. The presence or absence of woody debris will be further observed using sediment-profile imaging and during coring in the 2024 TLC Pilot Project PDI.

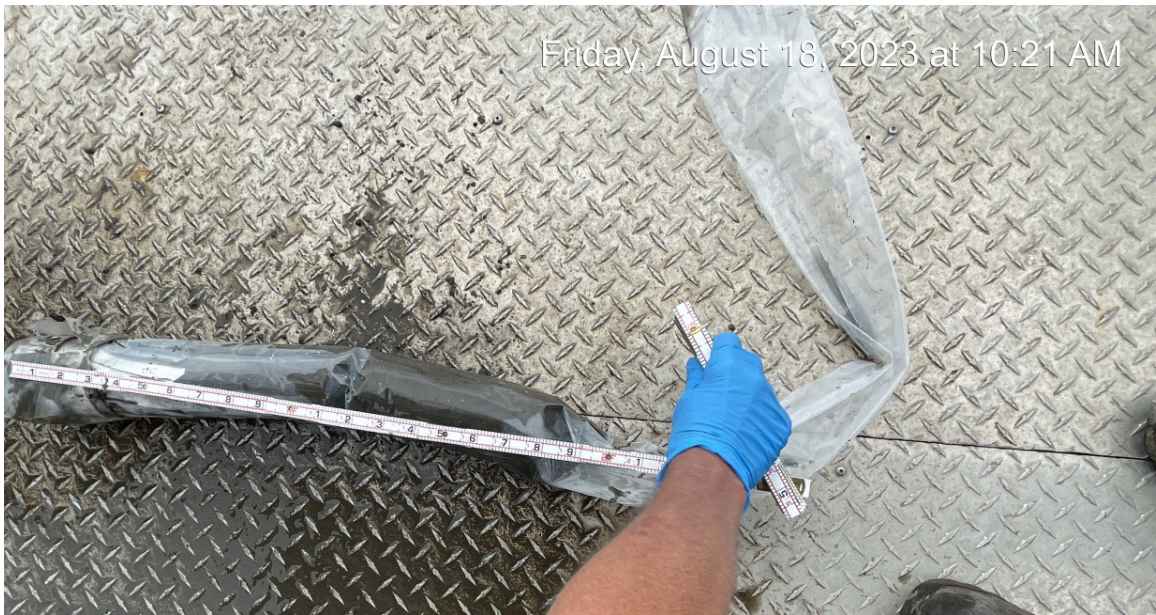
Photograph 22. East Cove 7 OR-PDI-34 (August 18, 2023)

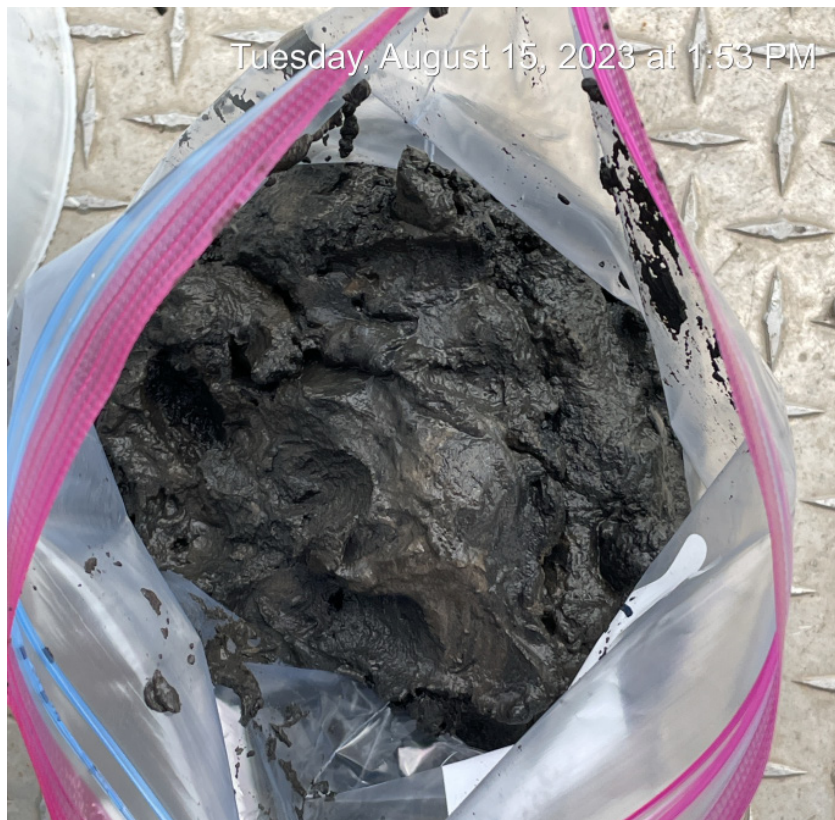
Photograph 29. East Cove 7 OR-PDI-41 (August 15, 2023)

- The field crew repeatedly encountered refusal of the box core at 0.5 to 0.8 ft bss and, based on previous experience, theorized that there is a denser underlying layer preventing further penetration. At East Cove 7 location OR-PDI-41, the field crew attempted to push a high-density polyethylene Lexan liner to collect a deeper sample, but could not advance the Lexan liner deeper than the box core taken at the same location, despite exerting a greater force. The Lexan liner was also attempted at East Cove 3 location OR-PDI-04 (Figure 2); however, no sediment was recovered in this attempt.

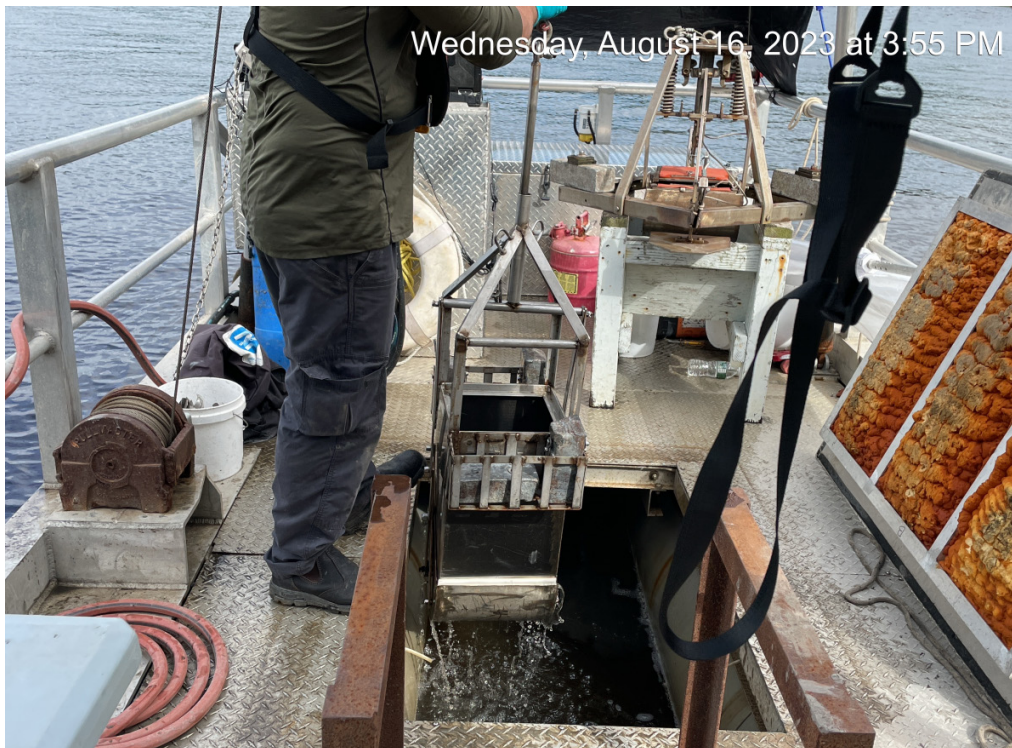
Photograph 35. Bald Hill Cove OR-PDI-58 (August 16, 2023)

Two sampling locations, OR-PDI-58 and OR-PDI-59, in the western shoreline cove area designated as “Area F” (Figure 3), were added to the study per discussions with the Remediation Trust during the August 2023 sampling event. Samples were not collected from 25 of the locations identified in the Work Plan because property owners did not grant access to collect the proposed samples (Table 4).

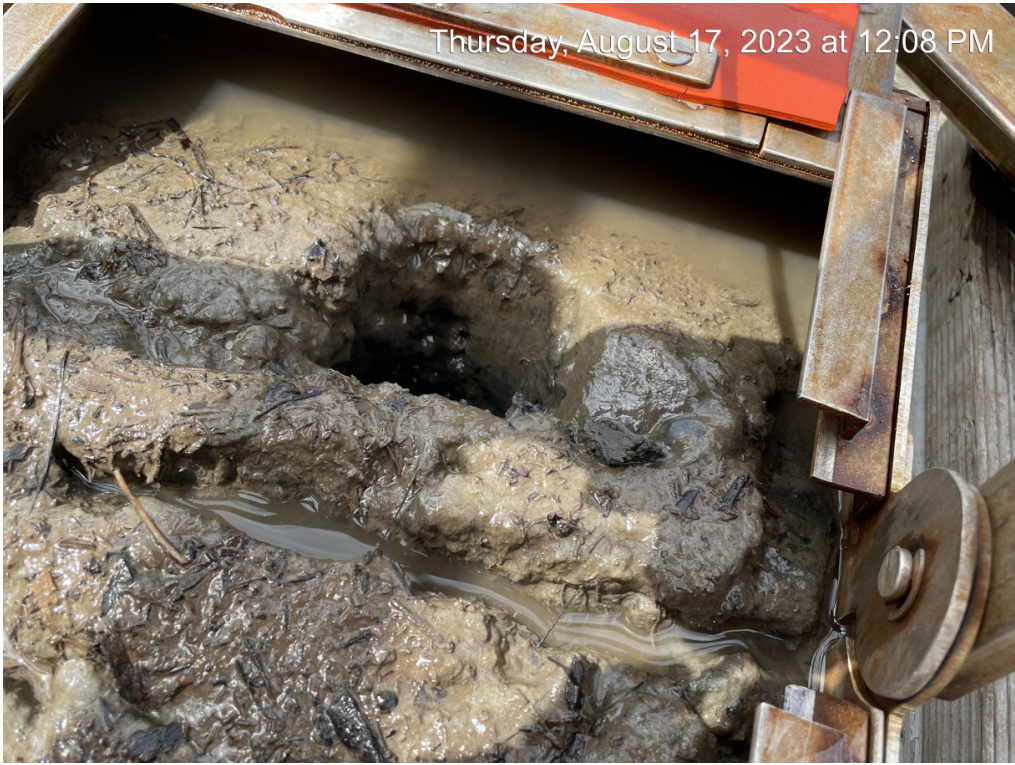
Photograph 36. Bald Hill Cove OR-PDI-59 (August 17, 2023)

Date	Time	Deployment #	Recovery (percentage)	Description	Sample Id #
08/17/23	12:21	1	40	SILTY SAND. Fine grained, soft, loose, wet, no plasticity, non cohesive, few gravels, no odor, poorly graded.	OR-PDI-59_081723_SEE

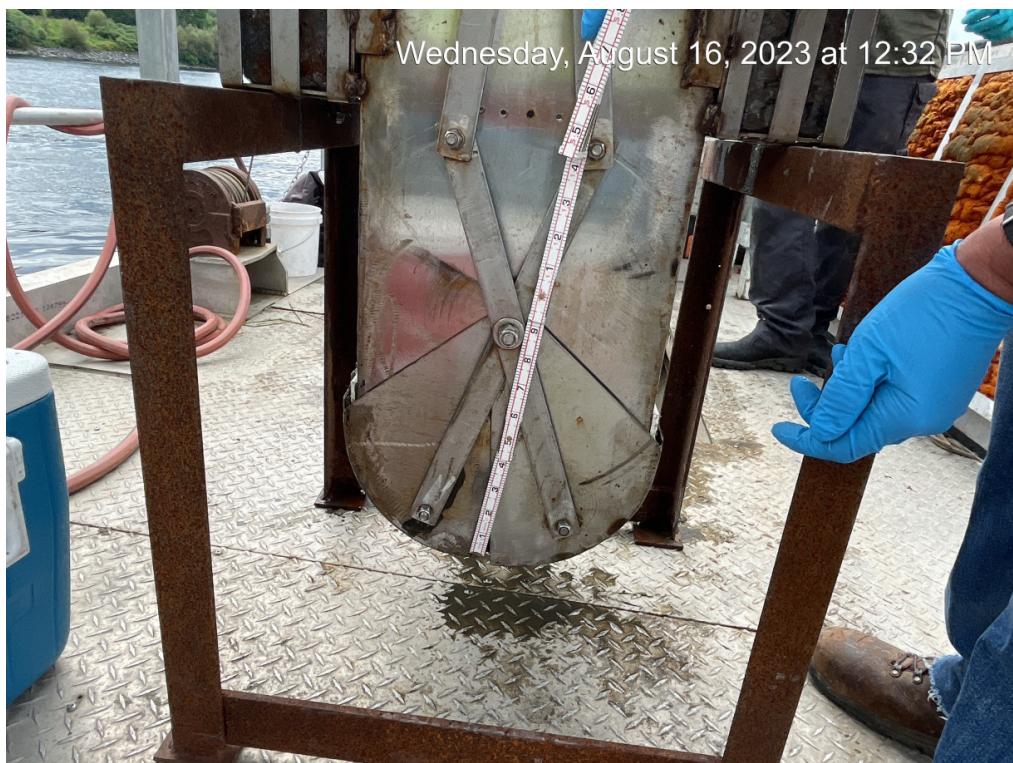
Photograph 37. Box Corer (August 16, 2023)

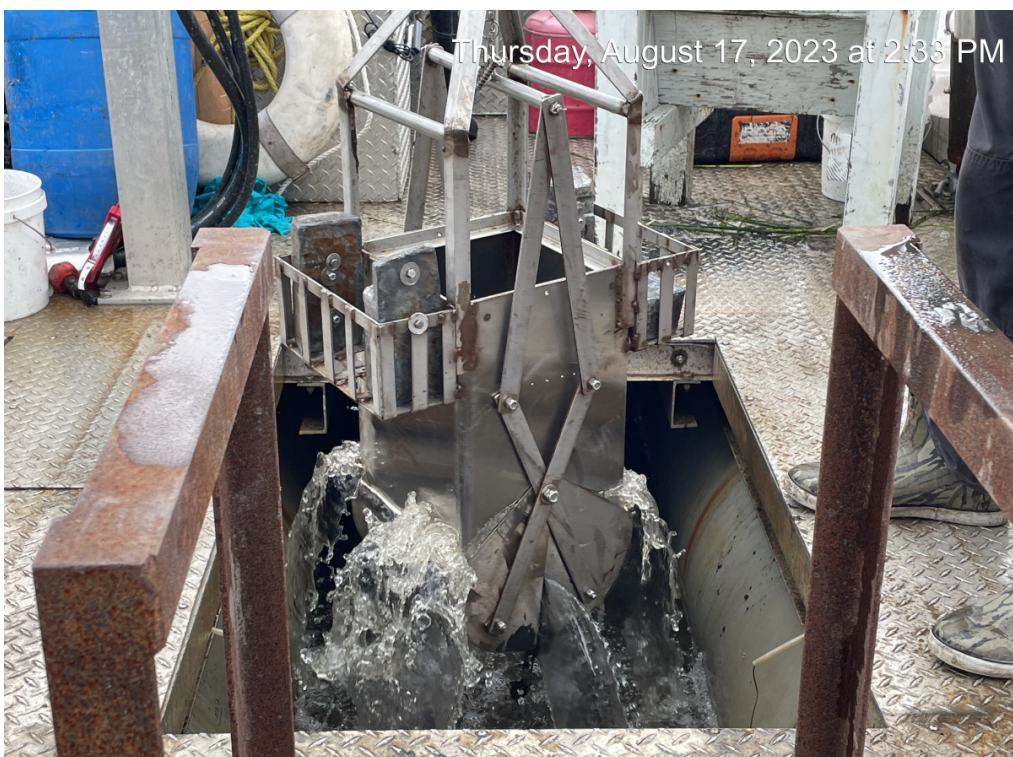
Photograph 38. Box Corer (August 17, 2023)

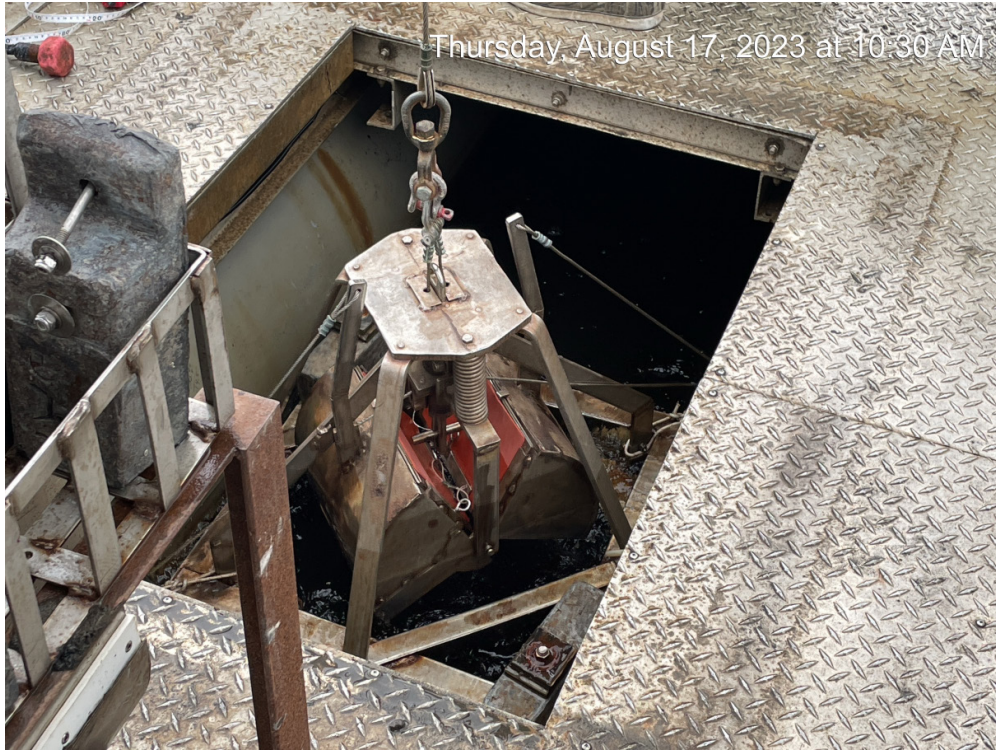
Photograph 39. Ponar Dredge (August 17, 2023)

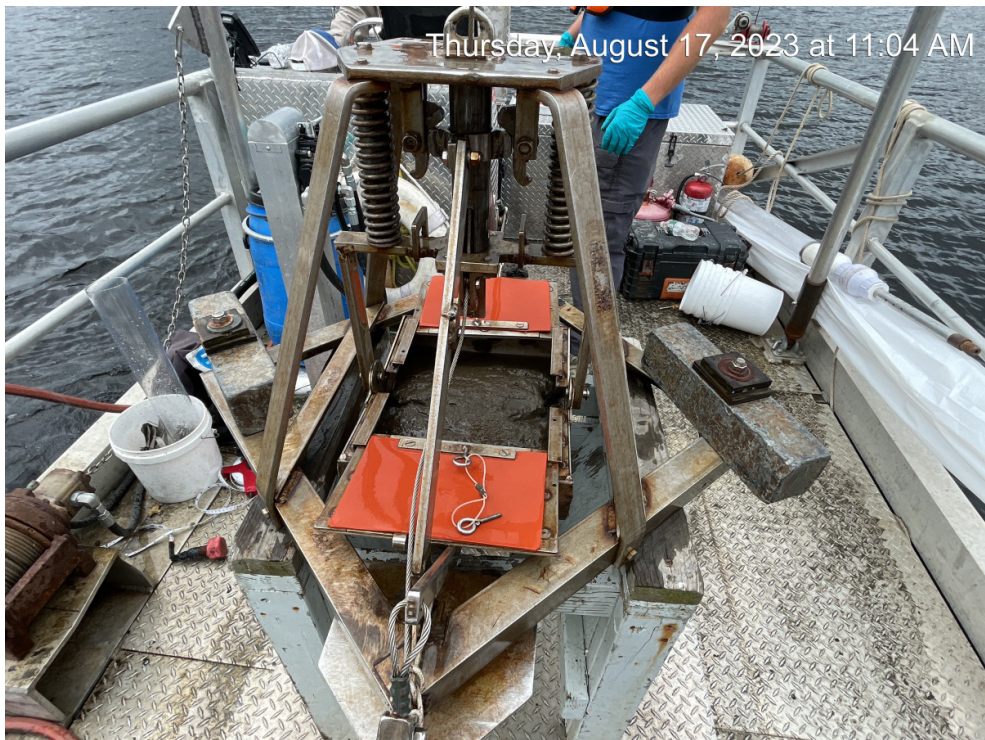
Photograph 40. Ponar Dredge (August 17, 2023)

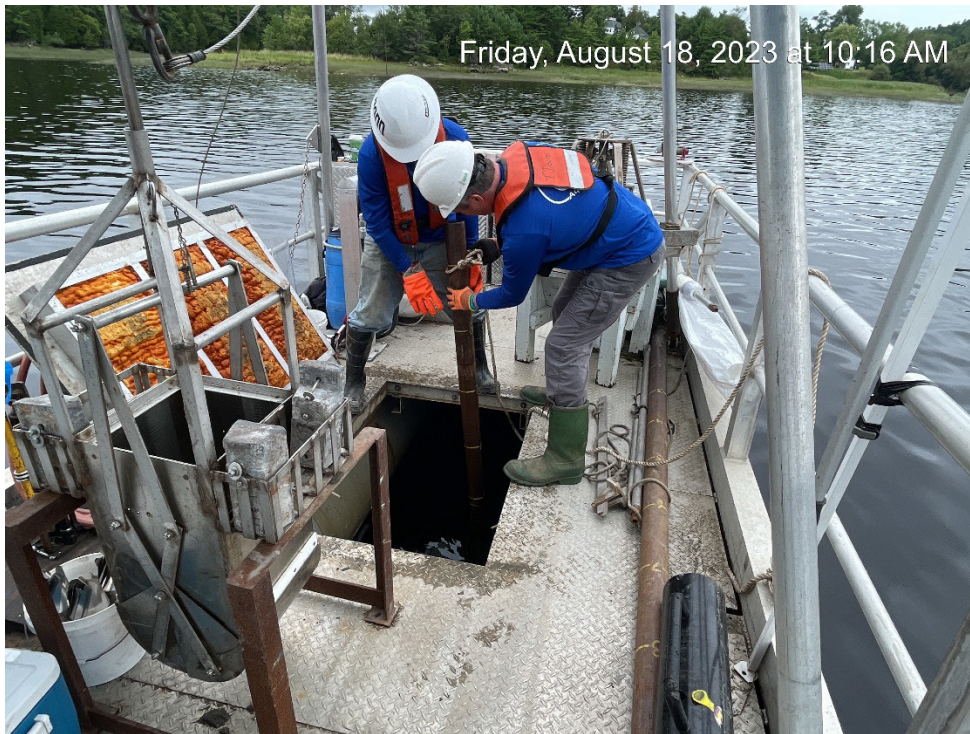
- The slam bar method was not used again during the August 2023 event as it was determined by the field crew to potentially be unsafe.

Photograph 41. Slam Bar in Use at OR-PDI-34 (August 18, 2023)

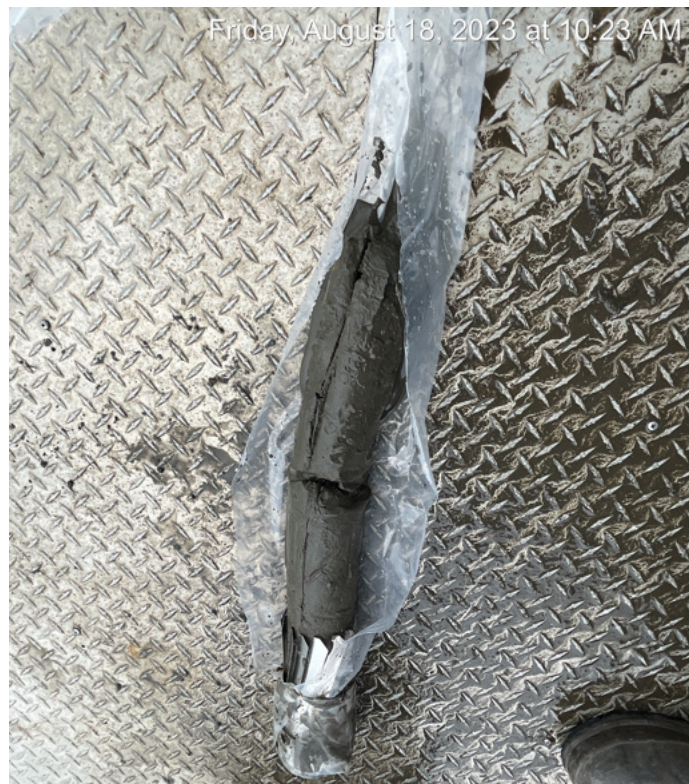
Photograph 42. Material Recovered with Slam Bar at OR-PDI-34 (August 18, 2023)
